Great Lakes Maritime Research Institute

Development and Succession of Microbial Communities Associated with Corroding Steel Pilings in the Duluth-Superior Harbor

Interim Report

November 15, 2008

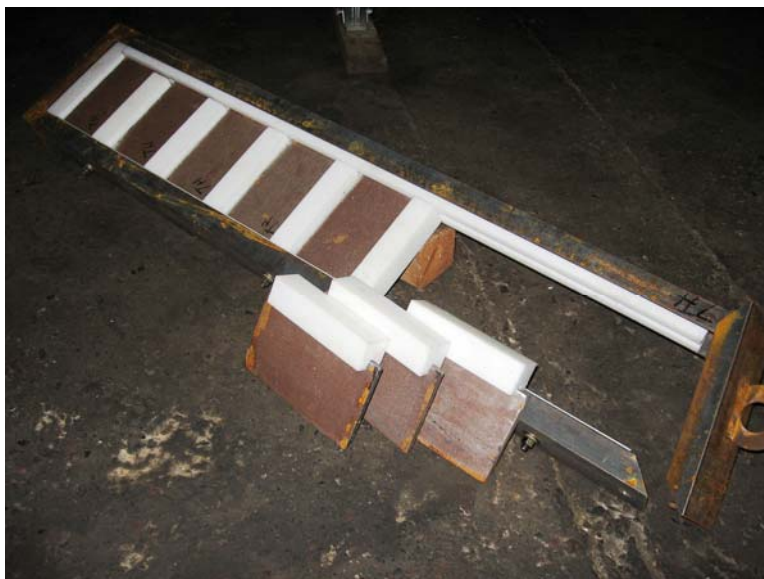
Figure 2. Photograph of metal tray frame and sheet steel coupons (separated by white HDPE spacers) before being installed in the Duluth-Superior Harbor during October 2006. [Photograph courtesy of AMI Consulting Engineers]

Metal tray frames containing sheet steel coupons were attached 1 meter below the waterline to corroding structures at six sites in the DSH between October 3 and 17, 2006 by AMI Consulting Engineers (Fig. 1). These six sites span the spectrum of low to high corrosion environments in the DSH: Duluth Seaway Port Authority berth 4 (DSPA), Cutler Magner Co. dock (CM), Hallett Dock 5 (HD5), Hallett Dock 7 (HD7), Midwest Energy dock (MWE), and the Oliver Bridge (OB). Each tray contains eight (0.375 inch thick), rectangular steel coupons (4.5 x 7.5 inches) cut from hot rolled ASTM-A328 steel, the same material used to construct steel sheet pilings used for docks and bulkheads in many parts of this harbor. Each coupon was weighed on a certified scale to the nearest 0.1 gram before being placed in the harbor and isolated from the steel tray frame and other coupons with HDPE plastic spacers (Fig. 2).
